Columbia, KY RCP Culverts

Abstract

The prime contractor for the Columbia Bi-Pass project for the Kentucky Department of Transportation District 8 faced an expensive problem with little time for decision making. This Field Report presents an existing application where an installation of a Reinforced Concrete Pipes (RCP) pipe just one year before was failing and rehabilitated using Snap-Tite HDPE Pipe.

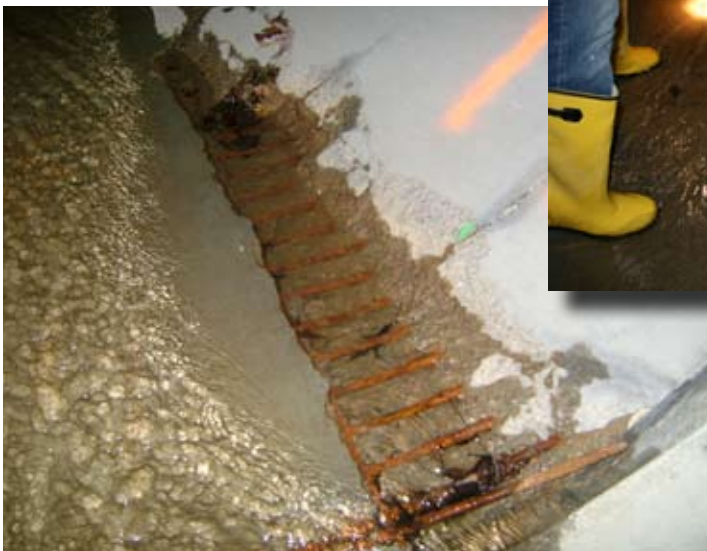
You can see the cracking and exposed re-bar on the original RCP.

Cracking along the parts of the culvert were popping up, along with exposed re-bar inside the pipe. The joints started to separate, exposing the gaskets. On the southbound pipe the water on the inlet side was actually flowing under the first two sections of the RCP pipes. And, in one part of the northbound pipe, the RCP had collapsed over eight inches. At this rate, the culvert was due to collapse at any moment.

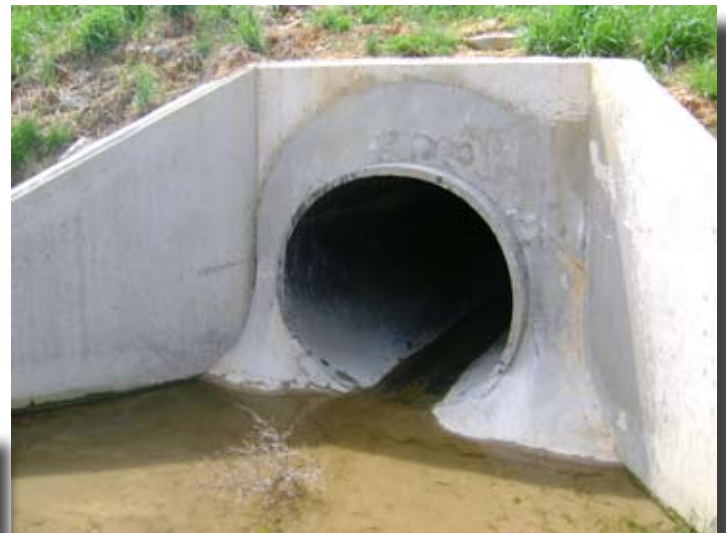
The completely rehabilitated culvert.

They then grouted the liner into place a few days later, completing the project with a culvert better than before and with increased flow capabilities.

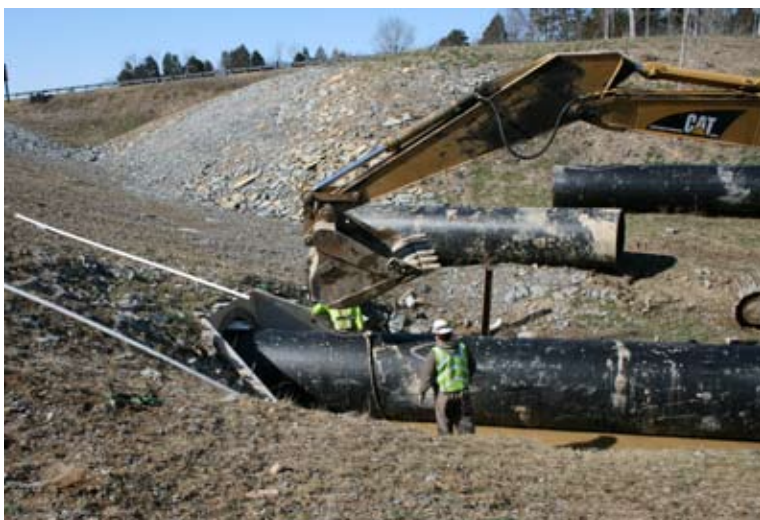
The Snap-Tite installation.

Before the crew snapped and installed the Snap-Tite liner, they prepped inside the old culvert. They installed grouting tubes along the top of the culverts and pumped grout on the inlet side of the southbound pipe to get the water to actually flow inside the culvert instead of under it. Then Indiana Reline snapped the pipe together and inserted it into both culverts. Once they pushed the pipe completely into the space, the crew built bulkheads on each end of the pipes to keep the soon-to-be pumped grout from flowing out.
