WSDOT Relines CMP Culvert, Designs Solution to Chronic Erosion

White Pass, WA

Abstract

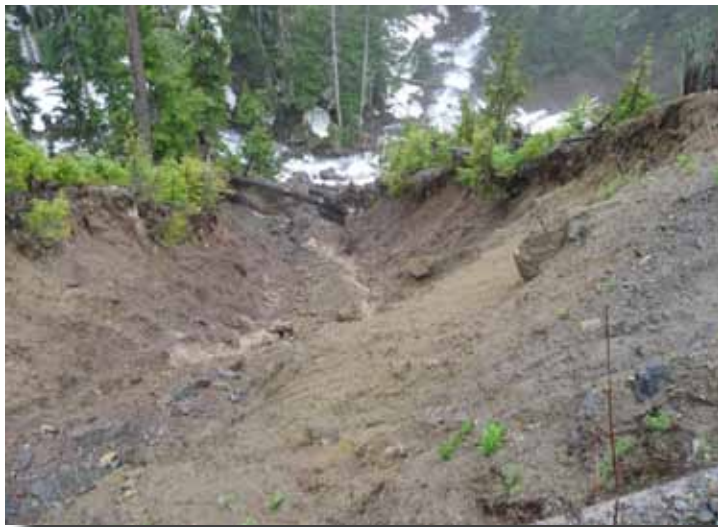
Alongside US12 near the summit of White Pass an existing 36-inch corrugated metal pipe (CMP) culvert conveyed water under the traveled lanes from an upstream gully and ditch. The outlet of the culvert was originally designed at ground level with a conventional rock riprap energy dissipater, which over time was washed down to a creek at the toe of the slope. The steep slope limited certain de-

Figure 2: Looking down-slope from the culvert outfall.

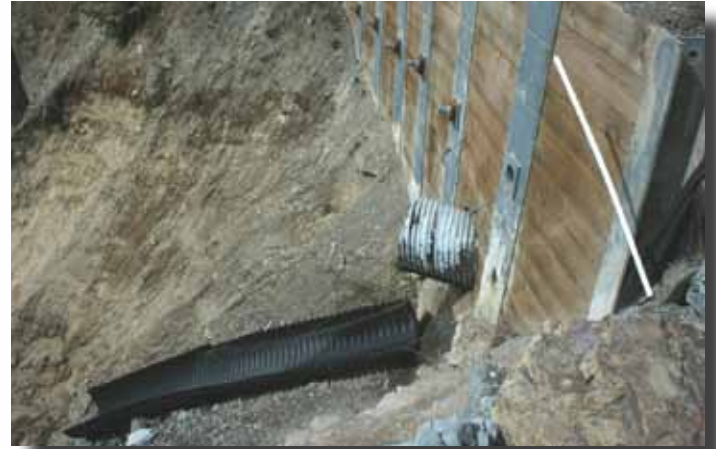
Figure 1: The 36-inch CMP with a half-pipe included as a temporary fix to the failing culvert.

Grey Langemo and Bob Boyes of Grecor-LLC, the Snap-Tite representatives in Olympia, WA, worked with Casey Kramer, P.E. and Jay Christianson from the Headquarters Hydraulics Office for the WSDOT to find a solution. The collaboration resulted in the decision to use 28-inch Snap-Tite high-density polyethylene (HDPE) pipe to slip-line into the existing 36-inch crushed CMP. In addition, a 36-inch HDPE drainage basin served as a transition between the

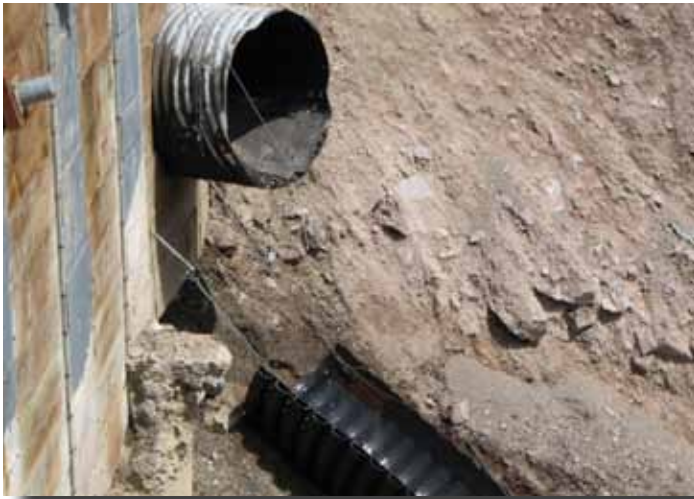
The outlet of the old culvert had a significant amount of erosion that over time lowered the ground-line by more than three feet. This exposed the bottom of a soldier pile wall allowing backfill material to escape below the lagging, which compromised the stability of the roadway.

Figure 3: Outfall at the soldier pile wall showing the exposed lagging

slip-lined and down-slope pipe. Finally, a 24-inch Snap-Tite down-slope pipe was used and anchored with cables to H-Piles. The design used a unique streamlined anchoring system consisting of three-fourths inch cable with customized pipe clamps to reduce drag forces on the down-slope pipe from snow, ice and plowing activities.

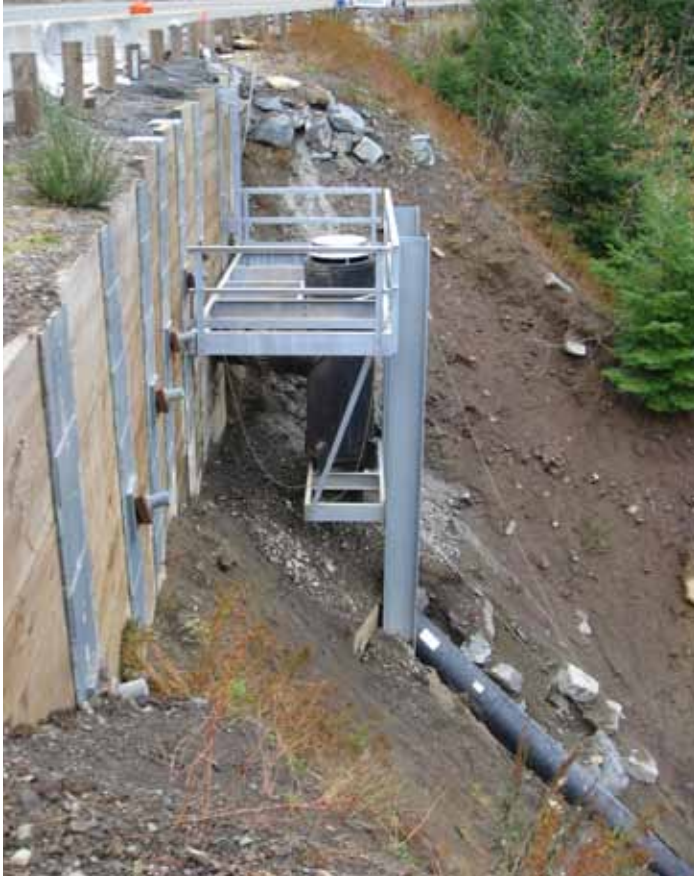
Figure 4: The installation complete.

The design ultimately allowed for safe delivery of water under the roadway and eliminated erosion at the face of the wall. The project also minimized the amount of sediment entering the stream at the toe of the slope and allowed for easy maintenance access.

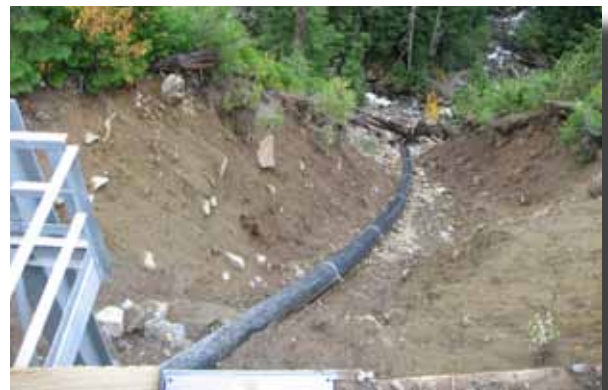
Figure 5: The down-slope pipe.
